DYNAMIC FULL SCALE TESTS
OF
MEDIAN BARRIERS

John L. Beaton

Robert N. Field

Presented at the 39th Annual Meeting of the
Highway Research Board, Washington, D. C.
January 11-15, 1960

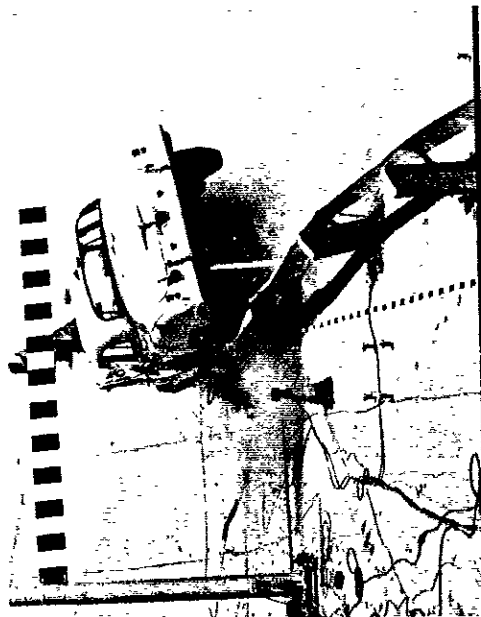
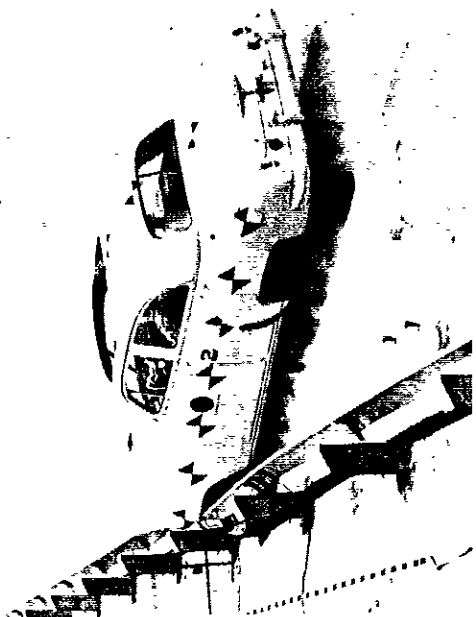
GUARDRAIL	W Section	DUMMY INJURY	Left shoulder & side injuries. Possible concussion.	TEST NO.	1
BRACKET	None	GUARDRAIL DAMAGE	3 Sections damaged beyond repair.	DATE	7-10-58
POST	8x8 D.F.	POST DAMAGE	2 Posts damaged beyond repair.	VEHICLE	Chev. 52 Sedan
POST SPACING	12'-6" O.C.	VEHICLE DAMAGE	12 Posts out of alignment.	SPEED	60 MPH
LENGTH OF INSTALLATION	212.5'	MAX. DYNAMIC DEFLECTION OF RAIL	48"	IMPACT ANGLE	27°
GROUND CONDITION	Dry			VEHICLE WEIGHT ...	3980
				(W/DUMMY & INSTRUMENTATION)

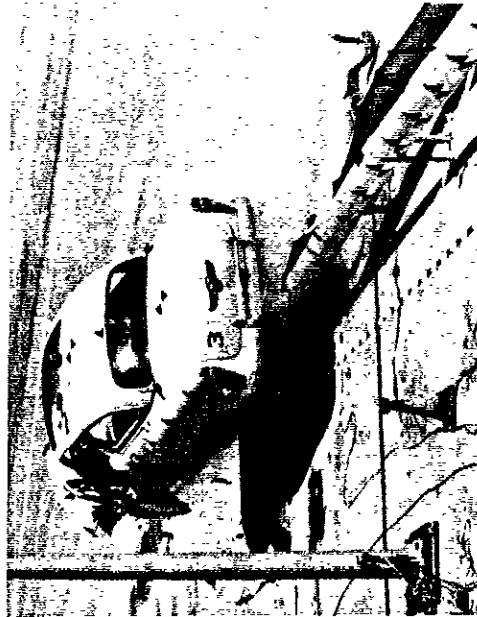
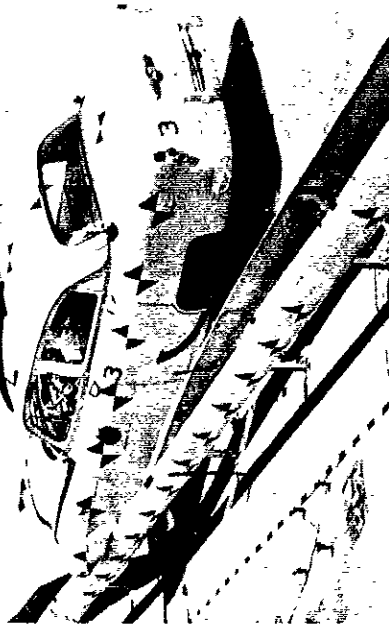
GUARDRAIL Tuthill
 BRACKET H615N
 POST 8x8 D.F.
 POST SPACING 10' O.C.
 LENGTH OF INSTALLATION 200'
 GROUND CONDITION Dry

DUMMY INJURY Severe head, neck, chest, & internal injuries.

GUARDRAIL DAMAGE 4 Sections damaged beyond repair.

POST DAMAGE 5 Posts damaged beyond repair.

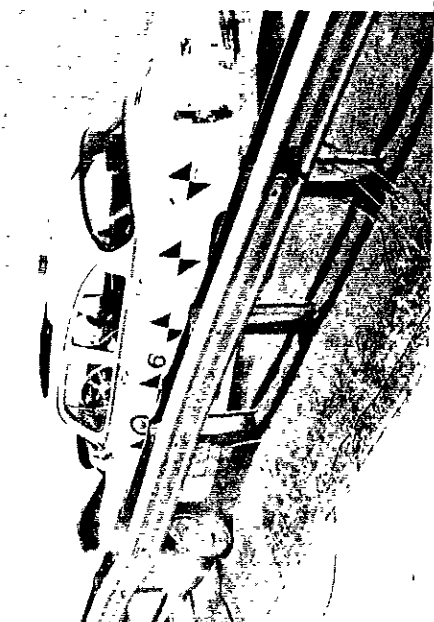
GUARDRAIL W Section
 BRACKET None
 POST 8x8 D.F.
 POST SPACING 6' 3" O.C.
 LENGTH OF INSTALLATION... 200'
 GROUND CONDITION Dry

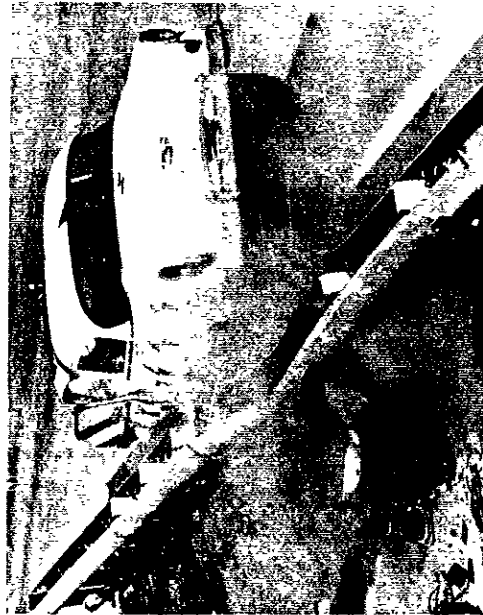
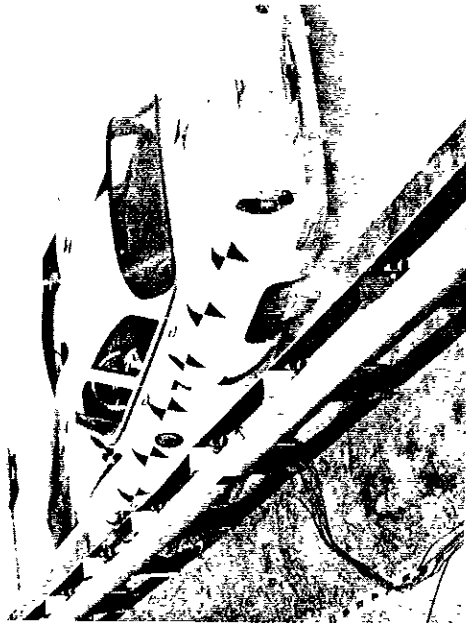
TEST NO.6
DATE9-
VEHICLECh
SPEED58
IMPACT ANGLE.....30
VEHICLE WEIGHT....40
LW/DUMMY & INSTRUMENT

DUMMY INJURY Severe head, chest & neck injuries .
GUARDRAIL DAMAGE 4 Sections damaged beyond repair.

POST DAMAGE 3 Posts knocked out.
2 Posts out of alignment.

VEHICLE DAMAGE Total loss .
MAX. DYNAMIC DEFLECTION OF RAIL ... 36"

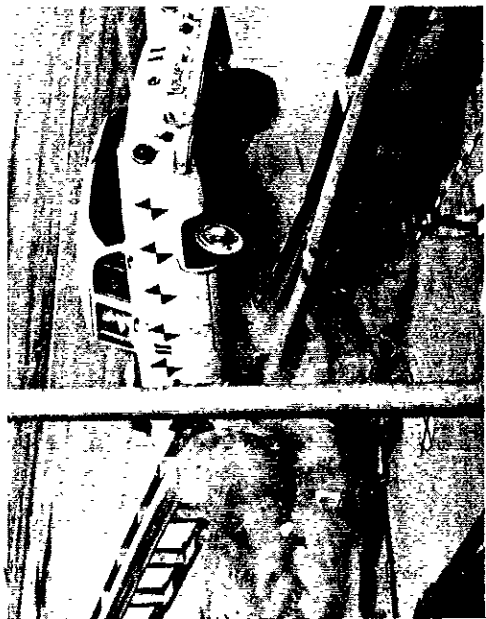
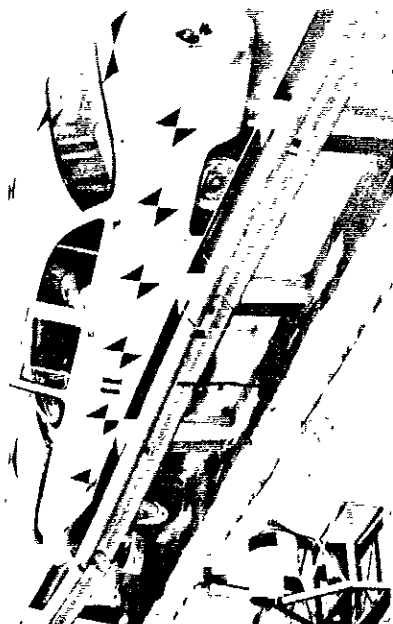
There has been some belief that a spring system for mounting a guard rail would tend to minimize damage to the offending car. It may be true under light collisions; however, under heavy collisions as presented by Test No. 9 (Exhibit 10), a flexible mounting tends to allow the rail to pocket between the posts. This results in a rail failure and the car passing on through the railing, thus it has little value as a positive barrier.

GUARDRAIL	Tutthill	DUMMY INJURY	Head, neck, chest & possible internal injuries.	TEST NO.	9
BRACKET	HG15N	GUARDRAIL DAMAGE	4 Sections damaged beyond repair.	DATE	10-15-58
POST	6" W 15.5 #		Both rails failed.	VEHICLE	Chev 54 Sedan
POST SPACING	6'-3" O.C.	POST DAMAGE	2 Posts damaged beyond repair.	SPEED	60 MPH
LENGTH OF INSTALLATION	100'		2 Posts out of alignment.	IMPACT ANGLE	28°
GROUND CONDITION	Dry	VEHICLE DAMAGE	Total loss.	VEHICLE WEIGHT	3970
		MAX. DYNAMIC DEFLECTION OF RAIL	15" Before failure.	(W/DUMMY & INSTRUMENTATION)

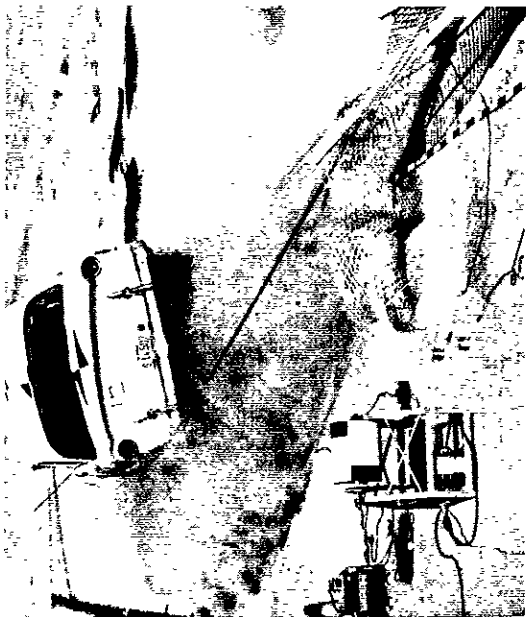
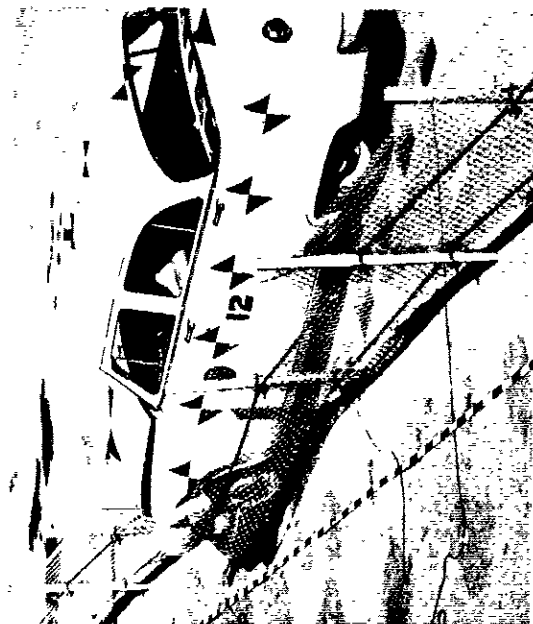
TEST NO. II
DATE 10-30-58
VEHICLE Ford 55 Sedan
SPEED 59 MPH
IMPACT ANGLE 26°
VEHICLE WEIGHT ... 4050
(W/DUMMY & INSTRUMENTATION)

DUMMY INJURY	Left shoulder & side, chest & internal injuries.
GUARDRAIL DAMAGE	6 Sections damaged beyond repair.
POST DAMAGE	3 Posts damaged beyond repair.
	3 Posts out of alignment.
VEHICLE DAMAGE	Total loss.
MAX. DYNAMIC DEFLECTION OF RAIL...40"

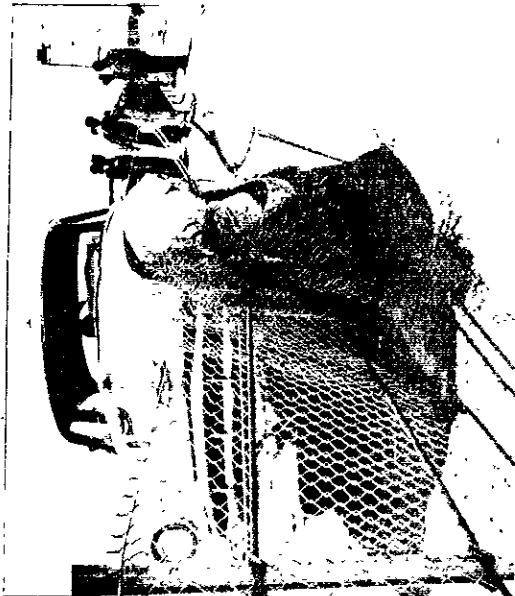
DUMMY INJURY Minor Bruises & possible neck injuries.

GUARDRAIL DAMAGE 80' of Fence knocked out. No damage to Cables.

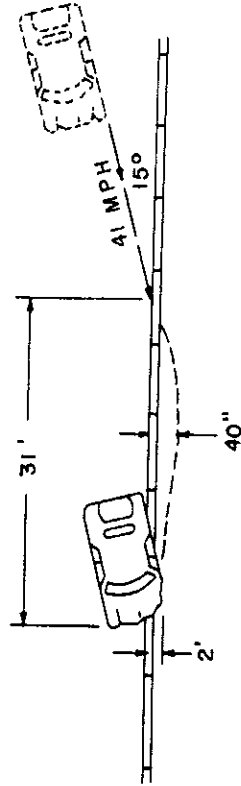
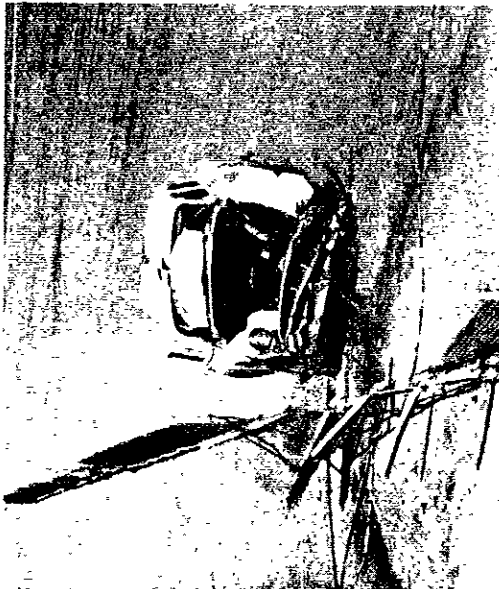
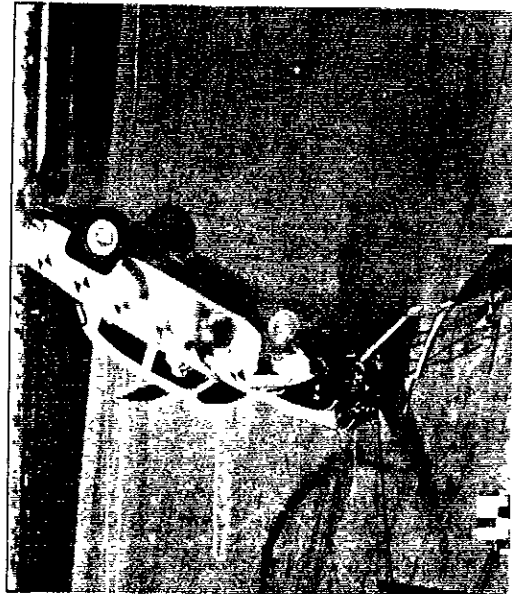
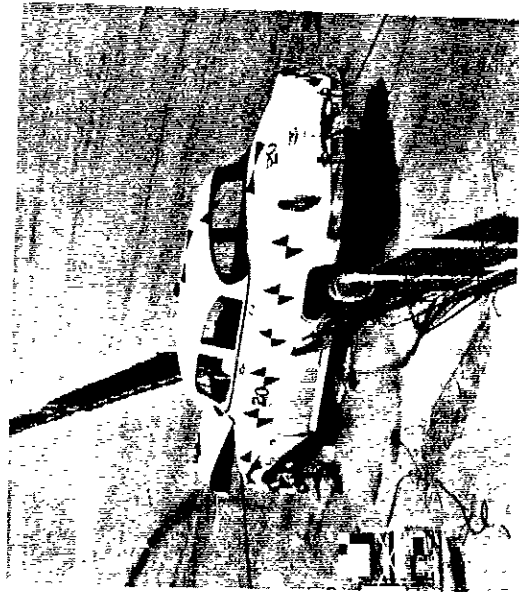
TEST NO 19
DATE 3-5-59
VEHICLE Chev. 53 Sedan
SPEED 41 MPH
IMPACT ANGLE 15°
VEHICLE WEIGHT 3700
(W/DUMMY & INSTRUMENTATION)

GUARDRAIL 36" Chain Link
Fence w/3/4" cables 9" & 30" above pvt.
POST 2 1/4" - 4.1 #
H Section Fence Post
POST SPACING 8' O.C.
LENGTH OF INSTALLATION 400'
GROUND CONDITION Dry

DUMMY INJURY Minor Bruises
GUARDRAIL DAMAGE 35' of Fence knocked out. No damage to cables.

POST DAMAGE 4 Posts damaged beyond repair.
VEHICLE DAMAGE \$ 400.
MAX. DYNAMIC DEFLECTION OF RAIL 40"
VEHICLE DECELERATION (PEAK) Long. 55 G ... Transv. 22 G
DUMMY DECELERATION (PEAK) Long. 3 G ... Transv. 2 G

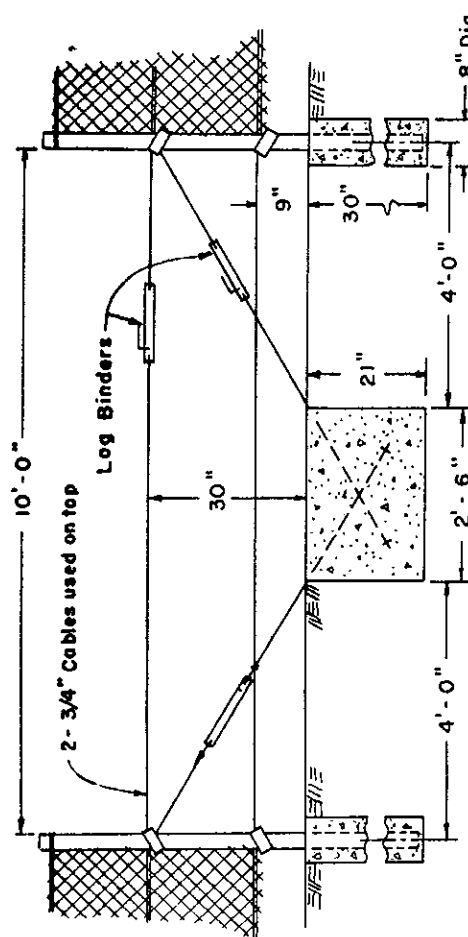
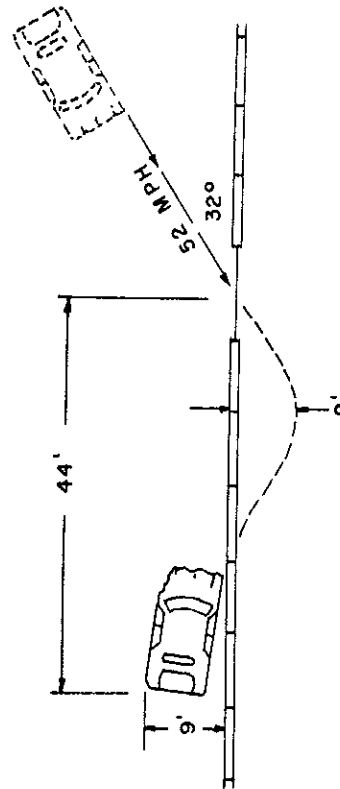
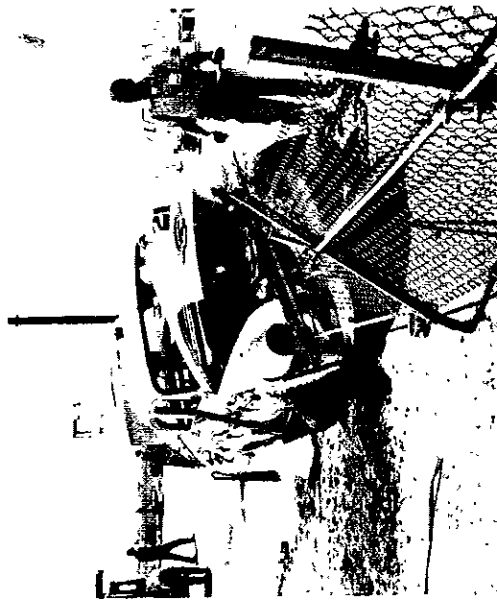
TEST NO. 20
DATE 3-10-59
VEHICLE Chev. 54 Sedan
SPEED 52 MPH
IMPACT ANGLE 32°
VEHICLE WEIGHT ... 3700
(W/DUMMY & INSTRUMENTATION)

GUARDRAIL..... 36" Chain Link
Fence w/ 3/4" cables 9" & 30" above
pvmf. Impact point at center of
emergency crossover.
POST..... 2 1/4" - 4.1 #
H Section Fence Post
POST SPACING..... 8' O. C.
LENGTH OF INSTALLATION... 400'
GROUND CONDITION..... Dry

DUMMY INJURY..... Severe Chest & Internal Injuries
GUARDRAIL DAMAGE..... 24' of Fence knocked out.
10' of Cable damaged.
POST DAMAGE..... 4 Posts damaged beyond repair.
2 Posts Bent.
VEHICLE DAMAGE..... Total Loss
MAX. DYNAMIC DEFLECTION OF RAIL... 9'
VEHICLE DECELERATION (PEAK)..... Long. 53 G ... Transv. 34 G
DUMMY DECELERATION (PEAK)..... Long. NG ... Transv. 6 G

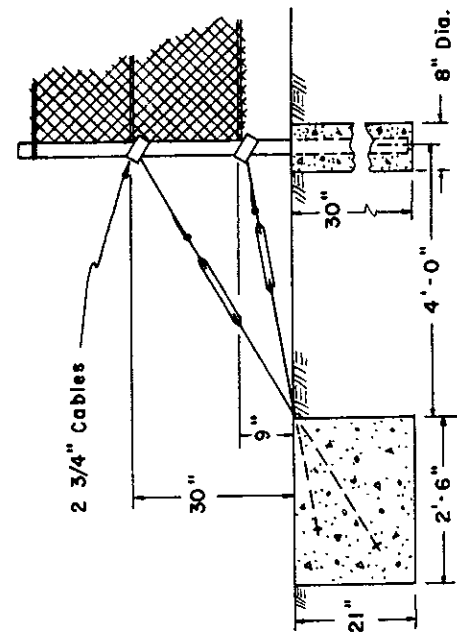
GUARDRAIL 36" Chain Link
Fence w/ 2 3/4" cables 9" & 30" above pvt.
POST 2 1/4" - 4.1 #
H Section Fence Post.
POST SPACING 8' O.C.
LENGTH OF INSTALLATION... 600'
GROUND CONDITION Wet

DUMMY INJURY Scalp laceration, possible chest injuries.
GUARDRAIL DAMAGE 56' of fence knocked out. No damage to cables.
POST DAMAGE 12 posts damaged beyond repair.
VEHICLE DAMAGE Total loss.
MAX. DYNAMIC DEFLECTION OF RAIL ... 8'
VEHICLE DECELERATION (PEAK) ... Long. NG ... Transv. NG
DUMMY DECELERATION (PEAK) Long. 6G ... Transv. 4G

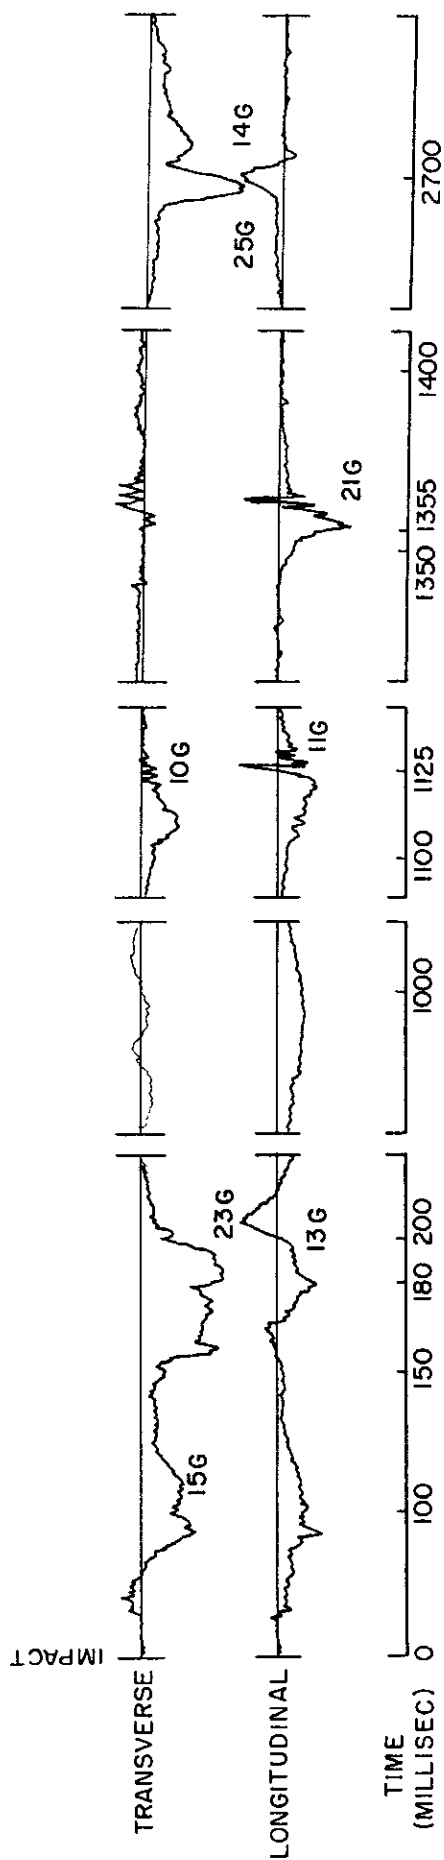
DUMMY DECELERATION PATTERN TEST NO. 22 CONCRETE WALL BARRIER

GUARDRAIL	36" Conc.	DUMMY INJURY	Concussion, severe shoulder & chest injuries.	TEST NO.	22
Wall, 6" Thick.		GUARDRAIL DAMAGE	20' Wall broken	DATE	3-30-59
REINFORCING BAR SPACING..	#4 at 12" Vert.	VEHICLE DAMAGE	Total loss	VEHICLE	Chev. 53 Sedan
	#4 at 18" Horiz.	MAX. DYNAMIC DEFLECTION OF RAIL..	22"	SPEED	61 MPH
LENGTH OF INSTALLATION...	85'	VEHICLE DECELERATION (PEAK)	Long. 112G... Transv. 72G	IMPACT ANGLE ...	30°
GROUND CONDITION	Wet	DUMMY DECELERATION (PEAK)	Long. 21G... Transv. 25G	VEHICLE WEIGHT ...	3850
				(W/DUMMY & INSTRUMENTATION)
